**Pratt Museum Kick-Off / Site Investigation
Meeting Notes
February 26, 2007**

QUESTIONS FROM THE FEBRUARY 26, 2007 INITIAL SITE MEETING**Overall, is it reasonable to make proposed modifications to this building, or should we consider a new building?**

Condition Survey

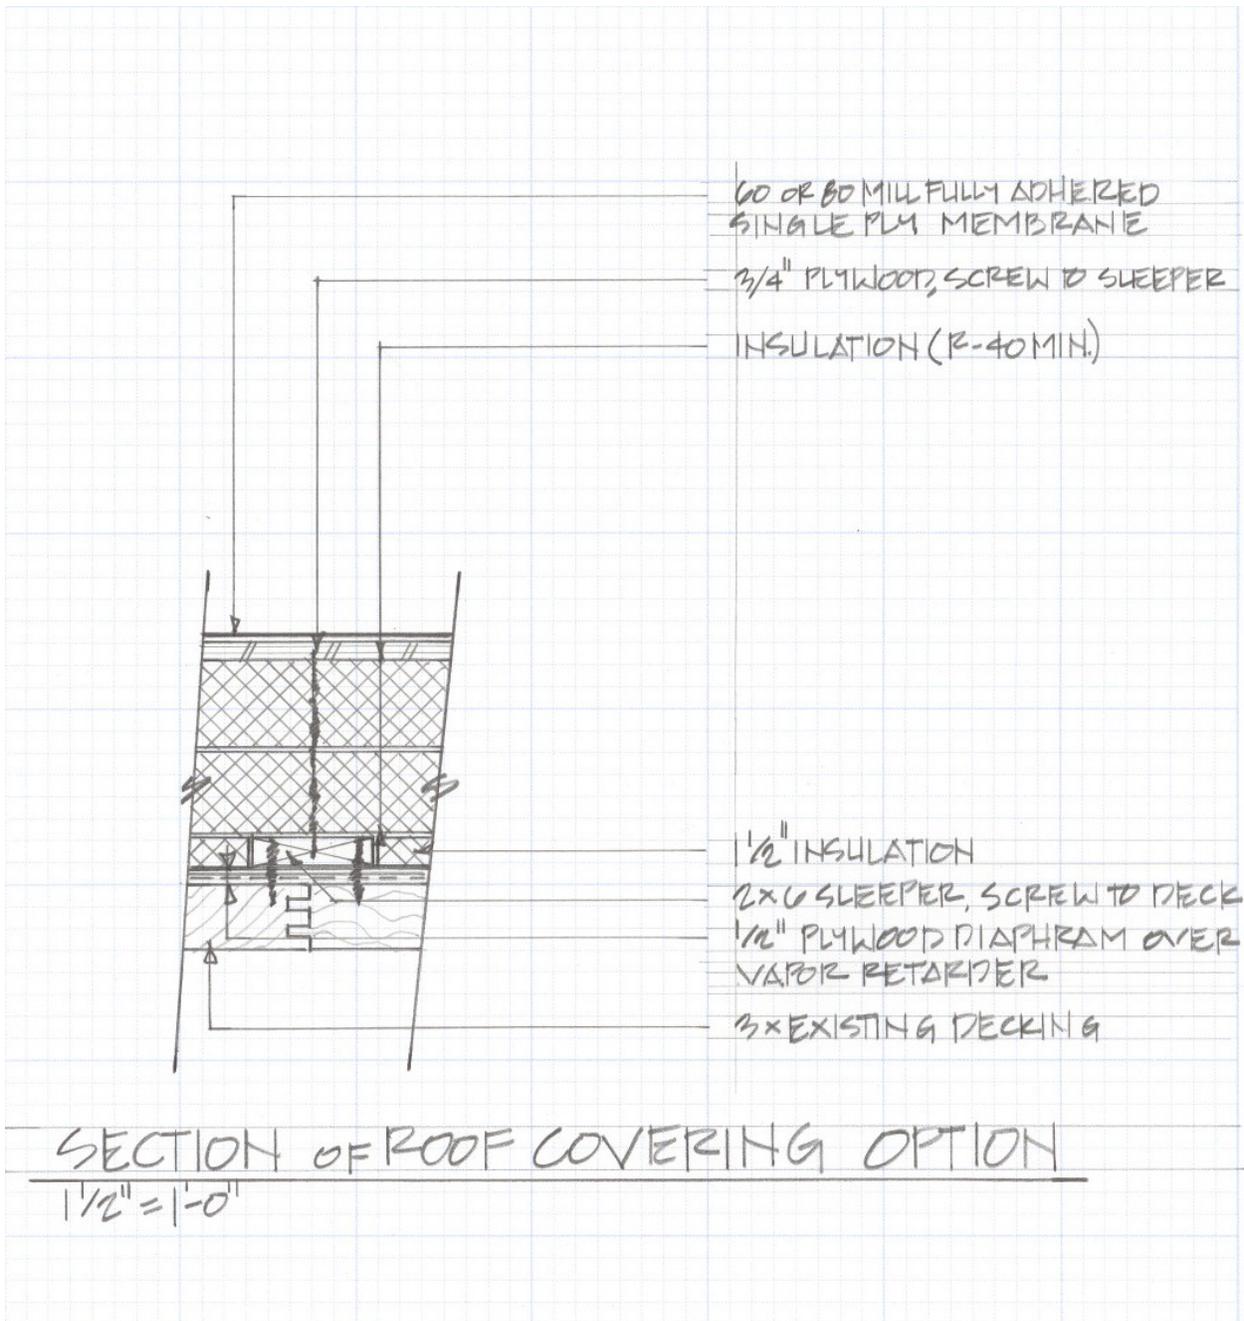
Roof Covering Detail
Figure 1

The existing roof is well over 20 years old and is past its expected life. The question is if the insulation under the roofing has become saturated with water. There is about a 50/50 chance the vapor pressure from within the building, or the persistent roof leaks through the roof have saturated the insulation. If this has occurred there is a high likelihood that the wooden roof deck is rotting. Destructive investigation could be undertaken that would help clarify this question. Unfortunately, such tests are only going to identify the specific areas tested (usually a series of 4 inch diameter holes) and could miss areas where a completely different condition exists. If sufficient funds could be raised I suggest the Museum receive quotes from roofers to provide a new 60 mil EPDM or PVC roof that is fully adhered to a new layer of ¾ inch thick plywood that is to be placed over the existing recycled insulation. The existing roof will need to be stripped down to the existing wood deck and the deck inspected for decay and mold growth. The new shear plywood described in the Condition Survey should be applied and a new 10 mil polyethylene vapor retarder installed. The roof's draining patterns should be assessed and redesigned to eliminate the current problem areas. The new roof slopes will likely be achieved through addition of specifically tapered plies of insulation placed over the decking and under the recycled roof insulation. As mentioned in the survey, insulation loses some insulating value with time. Also, the roof is structurally designed to accommodate a 40 pound per square foot (PSF) snow load. Existing conditions and the building code indicate 50 PSF should be used. A discussion with a structural engineer regarding the risk of adding insulation beyond what is currently on the Museum is recommended. The more insulation the more snow is retained and the more potential weight is added to the roof.

As mentioned, there is a chance some of the insulation will be unusable due to saturation and the roof decking could be rotten. A unit price for new insulation and decking replacement should be part of the contractor's bid package, that way a competitive pre-known price for the remedial work will be established. The roof structural system is in good condition, although designed for a live load that is approximately 20% below what is now recommended.
