PRATT MUSEUM
UPPER LEVEL -- January 2006

Condition Survey

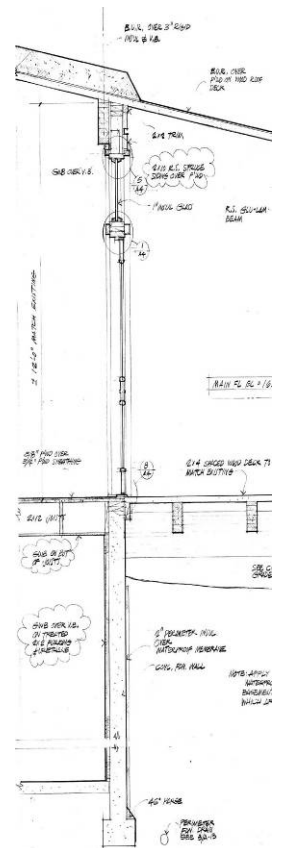
Portions of the exterior wall area are partially below grade. In those areas the wall assembly is 5/8 inch thick gypsum board over 2x2 treated wood furring with 1 inch thick rigid insulation between furring strips and a vapor retarder in the newer portion of the building. In the original building, ¼ inch thick plywood was applied over 2x2s without a vapor retarder or insulation. In either case, this assembly is attached to the concrete foundation which, on the addition, is covered with 2 inch thick extruded polystyrene over a waterproof membrane and varying depths of soil. The insulation and waterproofing on the 1968 original building is unknown. Some areas that are enclosed in this manner were cold, and insulation has been added to the inner wall surface and again covered with painted gypsum board.

There is no observed evidence of ongoing moisture migration through the concrete walls although there are reports of some lower level leaks when water entered the building through the in-floor electrical conduits during times of exceptionally high water or flooding conditions. This is exceptional performance considering the surface water drainage patterns, nearness of the creek to the building and the age of the foundation wall and waterproof membrane. If the collection is to remain on the lower level, enhancing the walls' waterproof performance is recommended to assure the exceptional waterproofing is maintained.

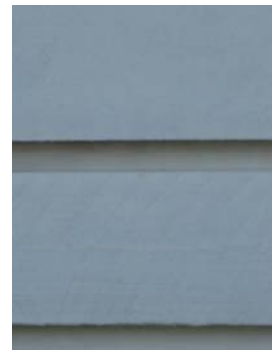
Infiltration of outdoor air and moisture present a problem for all wood structures where consistent humidity levels are desired. Infiltration becomes particularly problematic when humidification is added to the indoor environment. The most prevalent results of infiltration in South Central Alaska are cool drafty spaces, condensation within the wall cavity and the introduction of mold. In addition to the health concerns related to airborne mold spores, it is inevitable that wood rot will develop over time. Two commonly used methods to reduce air infiltration through building component joints are to install a monolithic vapor retarder on the interior face of the wall studs and to install an air barrier on the exterior face of the building sheathing. There are several newer air barrier products that allow moisture that does enter the wall cavity to escape, while prohibiting outdoor air from freely moving into the wall. The current plank style wall cladding over the building sheathing would make it very simple to add the air barrier over the partially exposed sheathing. This will require removing planks, adding the air barrier, covering the air barrier with new siding or sheathing and then replacing the existing planks. Special attention to the application of air barriers around doors, window and mechanical openings is required, and the installers need to be aware of these procedures to assure a good, tight product.

The Museum has another source of infiltration that is rather unusual; the 3x6 wood roof decking's VEE joint is exposed on the outer face of the building under the wood roof soffit. These slots to the outdoors allow free air movement every 5½ inches along the building perimeter and should be closed. One method is to force a low slump sealant such as Snonoborn NP-2 into the open joints at the wall/roof deck interface and then to cover the entire interface with a 2x2, 26 gauge sheet metal angle which would in turn be covered by the air barrier, siding and wood rake edge trim (See Figure 2 in Appendix D of this document).

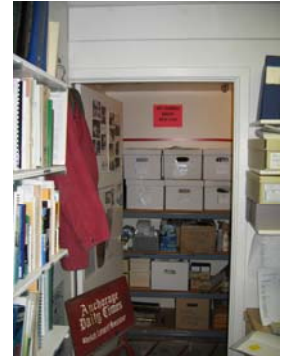
The curator’s office and archives space is positioned immediately north of the natural science collections. The 200-square-foot space is accessed through the lower gallery. The room’s condition is very similar to that found in the natural science collections with the exception of the added hazard in this space due to the sprinkler control riser and related plumbing. Leaks from this high pressure source could have devastating effects on the archives in a matter of minutes.

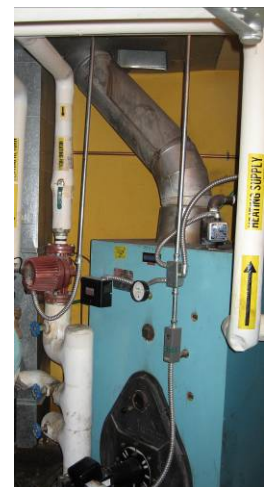
The boiler room contains one 763 MBH oil fired boiler (see Mechanical Description) and appears to meet the requirements of the heat generation for the building. The door into the boiler room is a rated door. It is not possible to confirm the wall fire rating without demolition; it does appear the room meets the one hour fire resistant requirements of IBC 302.1.1. As previously mentioned, the door into the Education Director's office creates an intervening room from the boiler, resulting in a noncompliant exiting path.

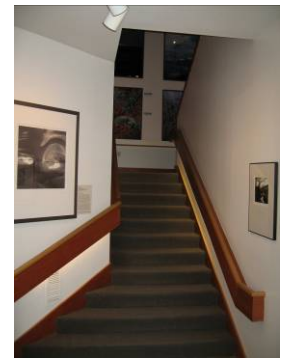
The monumental stair at the west end of the special exhibits gallery is well constructed and provides a visually attractive end for the special exhibits gallery. A large wall is created on the west end of the stair as the result of the stairs falling off the gallery floor level to the landing level. The 4½-foot addition to the height of the wall results in a very large display area that can be used to display a feature object or backdrop. There were no observed deficiencies in this space, however, constructing an accessible route to access the landing was suggested by staff members.

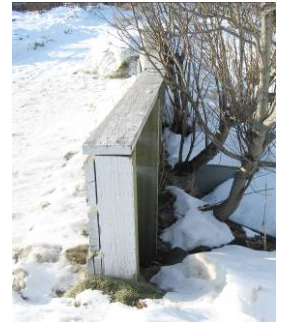
The Pratt Museum property consists of 5 separate parcels of land totaling approximately 9.39 acres. The terrain generally slopes north to south at an average slope of 10%. Woodard Creek runs across the site from north to south. A 48"x66" Pipe Arch culvert, approximately 120 feet long has been constructed in the Museum's west parking lot, and the creek has been diverted through the culvert.

The culvert presents a potential restriction of the stream channel. In the winter the culvert free opening is reduced by ice thus compounding the spring run-off. Additionally, the inlet has experienced some blockage in past flood events due to water-borne debris. The potential for blockage of the culvert presents a risk of flooding of the parking lot and, possibly, the basement. It is suspected that the shop building's sanitary sewer runs under the culvert and the domestic water to the shop runs over the culvert. The water line to the shop is prone to winter freeze up. The risk could be minimized by removing the culvert and reconstructing a stream channel through the site. Stream reconstruction would provide an opportunity to re-establish lost riparian habitat and to restore the flood control characteristics of a natural stream channels. If the stream is reconstructed it should be routed to the west, around the parking lot and well away from the building.

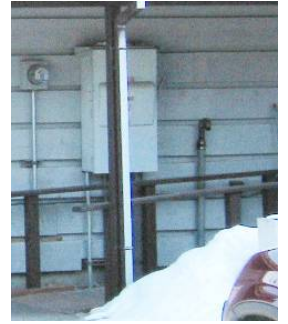
Electric Heat Trace: Electric heat trace serving the rear roof thaw cable and downspout heat trace was fed using an extension cord stapled to the siding. The heat trace circuits were all fed from a 6 mA personnel protection

receptacle. NEC requires heat trace cables to be protected with a 30 mA equipment type GFI breaker, rather than a 6 mA GFIC receptacle.
